Report R78-911989-14

Evaluation of Basic Laser  
Welding Capabilities

Technical Report  
Contract N00014-74-C-0423

E. R. Thompson, Manager  
Materials Sciences

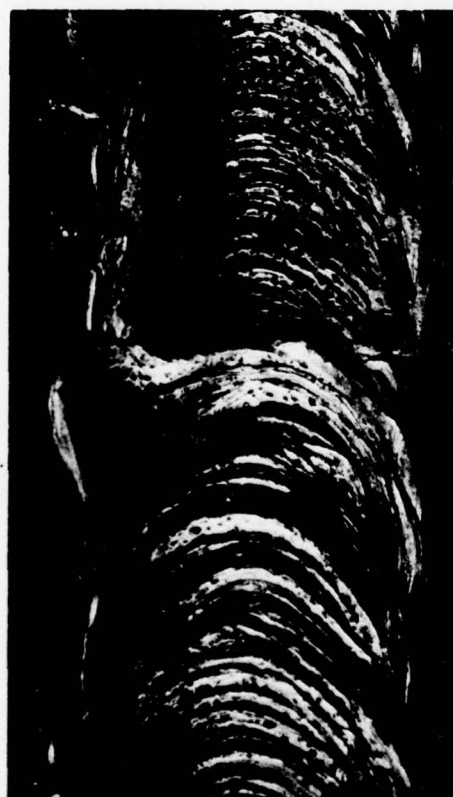
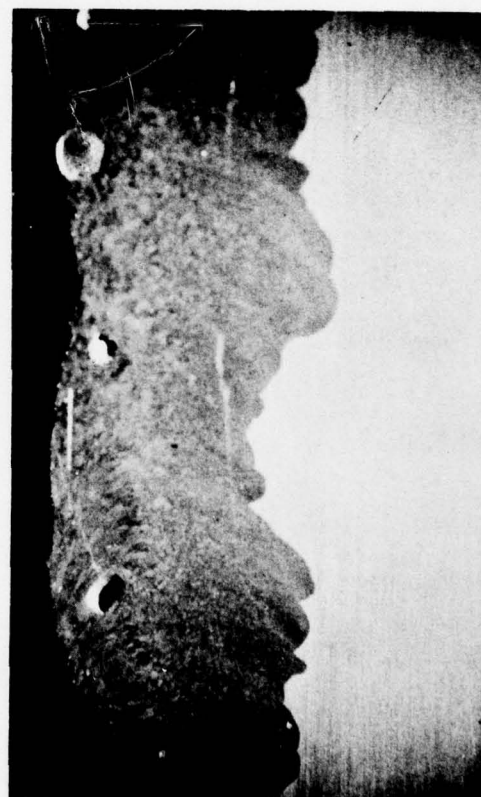
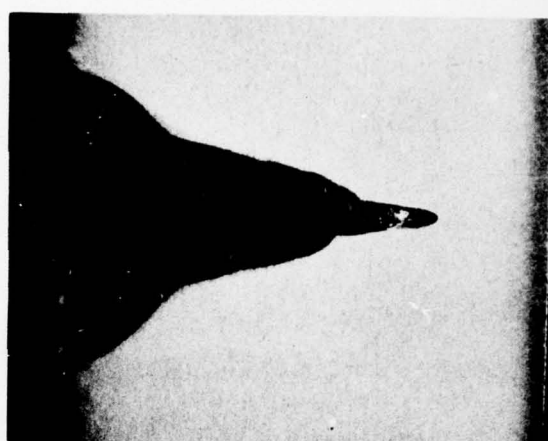
STRUCTURE OF WELD 35-1, 5086, TABLE III  
TOP SHIELD HELIUM FLOW RATE: 1.27 M<sup>3</sup>/HR. CROSS-JET ON. 8kW; 1.48 CM/S

A. WELD BEAD SURFACE  
← LASER BEAM TRAVERSE DIRECTION

C. WELD MICROSTRUCTURE,  
LONGITUDINAL SECTION

B. RADIOGRAPH OF WELD SECTION  
POROSITY APPEARS IN LIGHT CONTRAST

D. WELD MICROSTRUCTURE,  
TRANSVERSE SECTION

Use of the helium cross-jet to sweep plasma to one side of the beam path appeared to also aspirate air into the beam impingement area (Figs. 1-2 and run 35-1, Table III). However, considerable improvement in overbead surface appearance was achieved for both 5456 and 5086 by increasing the top surface shield gas flow through the diffuser plate surrounding the beam part (Figs. 3-7 and Table III). Under these shielding conditions, full penetration of 0.95 cm plate was achieved with 8 kW power setting at 1.19 cm/s traverse speed in 5456 and 9 kW, 1.48 cm/s in 5086.

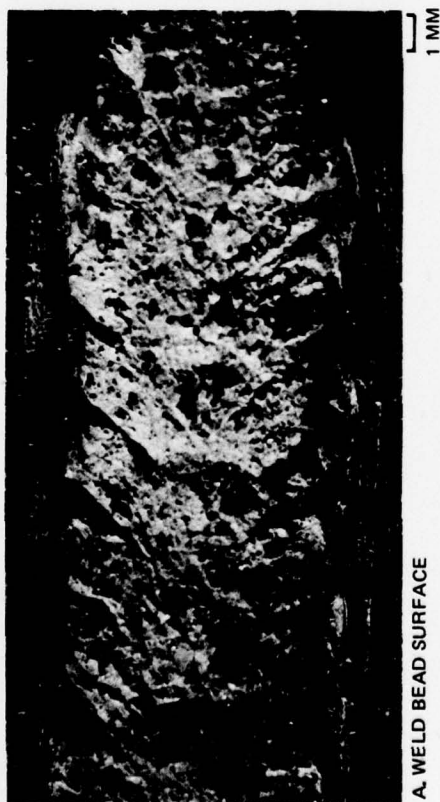
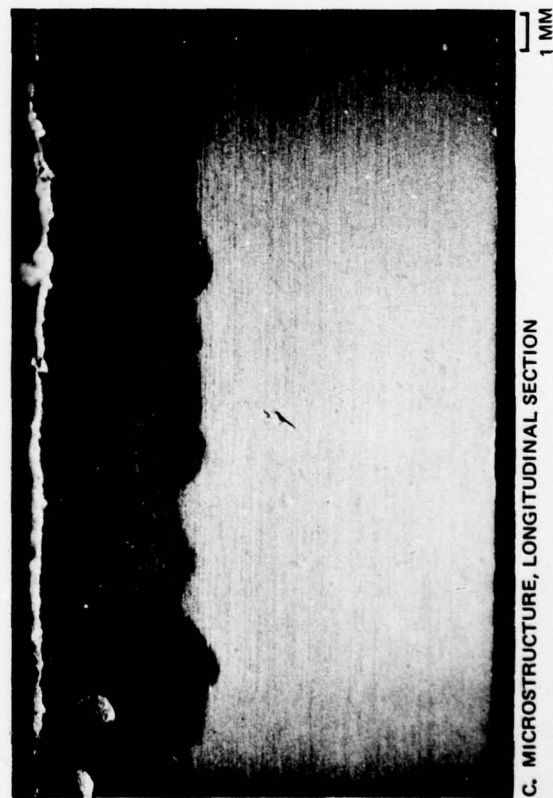
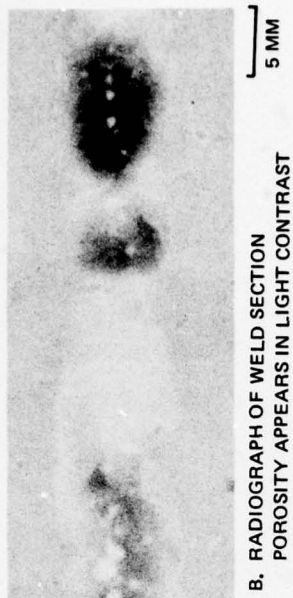
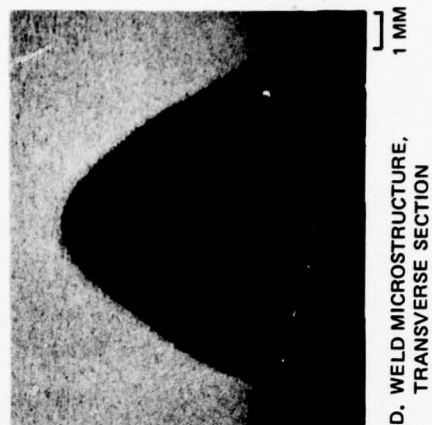
STRUCTURE OF WELD 35-2, 5086, TABLE III  
TOP SHIELD HELIUM FLOW RATE : 1.27 M<sup>3</sup>/HR. CROSS-JET OFF. 8 KW; 1.48 CM/S

← LASER BEAM TRAVERSE DIRECTION

Examination of the effects of shielding changes on plasma suppression and fusion zone depth were conducted with the same shielding enclosure utilized in the previous experiments (Fig. 2, Ref. 2). The shielding enclosure was positioned so that it cleared the workpiece by 0.05 in. A small nozzle was added which was positioned to direct a jet of helium across the workpiece surface, perpendicular to the beam traverse direction, at the point of beam impingement. Welds were made in the bead-on-plate configuration on 0.95 cm plate, using various laser beam power settings and beam traverse speeds, with the beam focal plane set  $4.8 \pm 0.2$  mm below the upper surface of the workpiece (Figs. 1-7 and Table III).

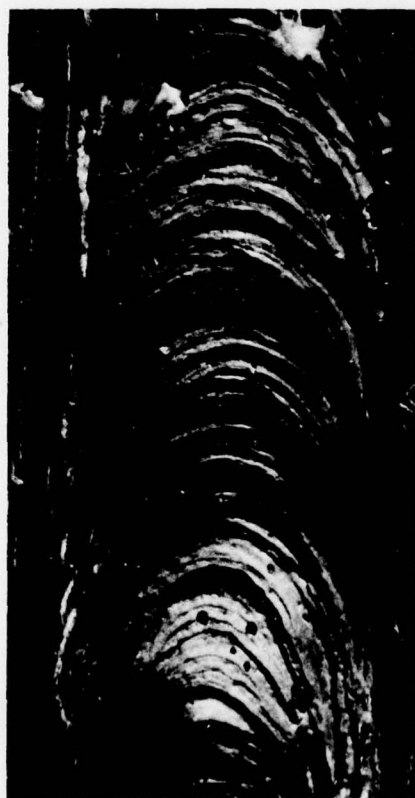
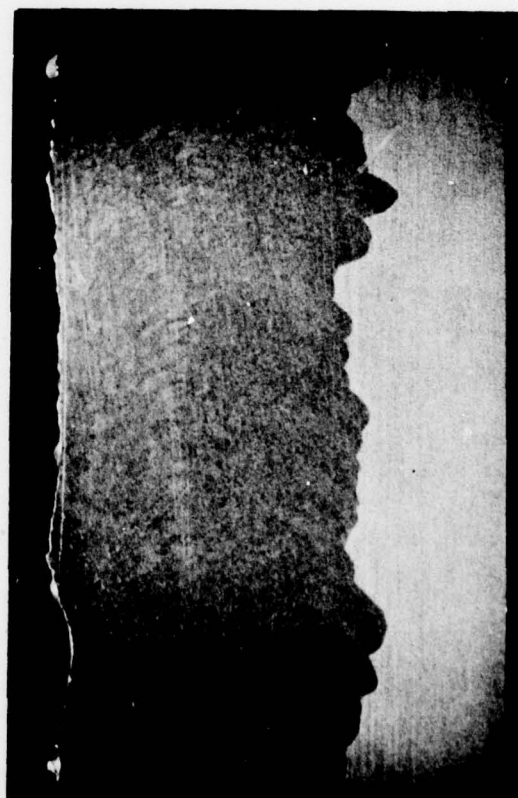
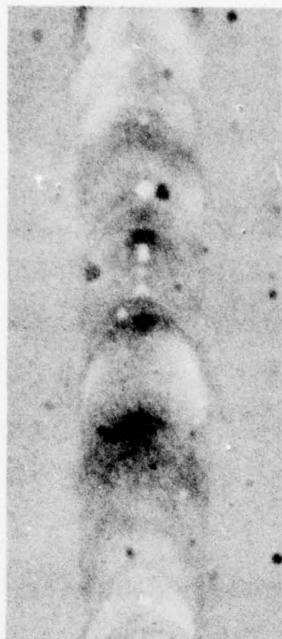
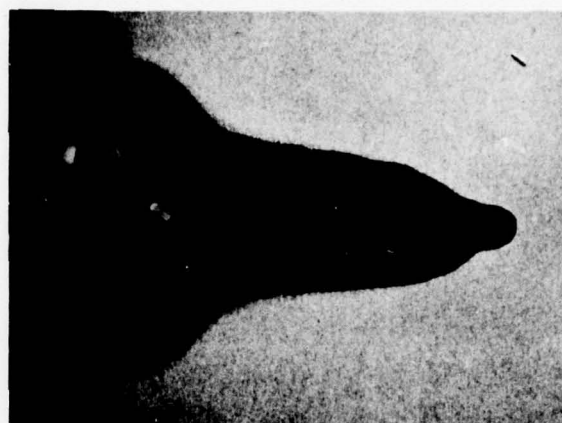
STRUCTURE OF WELD 35-3, 5086, TABLE III  
TOP SHIELD HELIUM FLOW RATE: 2.83 M<sup>3</sup>/HR. CROSS-JET OFF. 8 kW; 1.48 CM/S

A. WELD BEAD SURFACE

C. WELD MICROSTRUCTURE, LONGITUDINAL SECTION

B. RADIOGRAPH OF WELD SECTION  
POROSITY APPEARS IN LIGHT CONTRAST

D. WELD MICROSTRUCTURE,  
TRANSVERSE SECTION

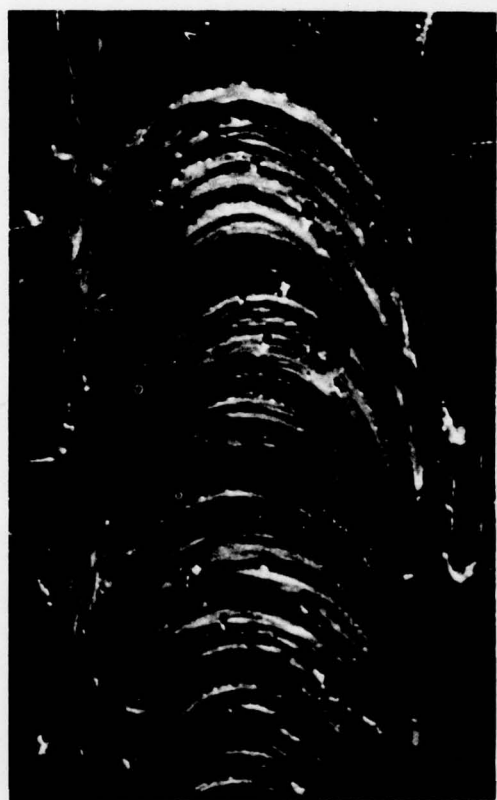
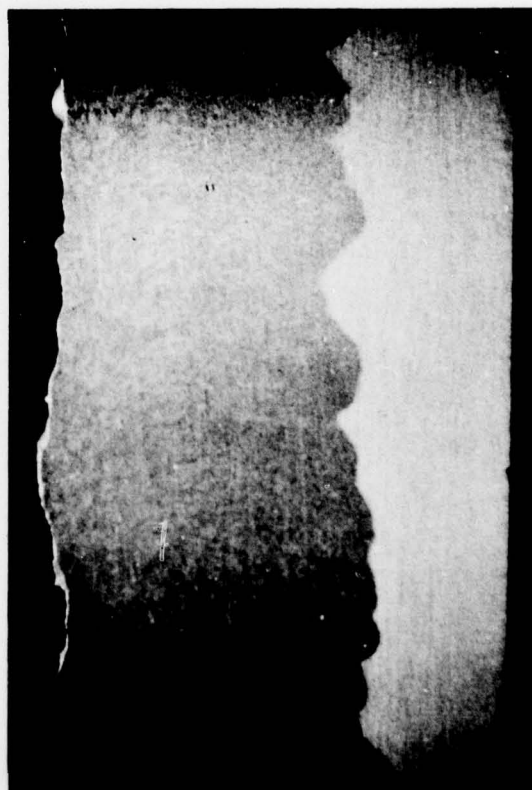
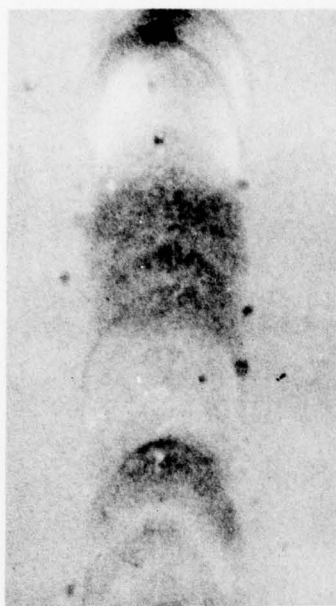
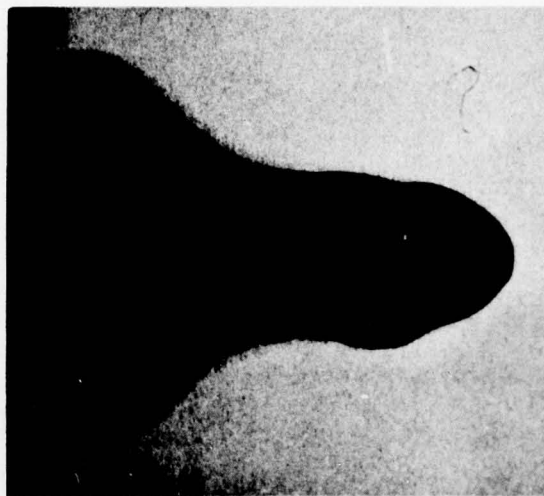
STRUCTURE OF WELD 35-4, 5086, TABLE III  
TOP SHIELD HELIUM FLOW RATE: 2.83 M<sup>3</sup>/HR. CROSS-JET OFF. 8 KW; 1.19 CM/S

A. WELD BEAD SURFACE

C. WELD MICROSTRUCTURE, LONGITUDINAL SECTION

B. RADIOGRAPH OF WELD SECTION  
POROSITY APPEARS IN LIGHT CONTRAST

D. WELD MICROSTRUCTURE,  
TRANSVERSE SECTION

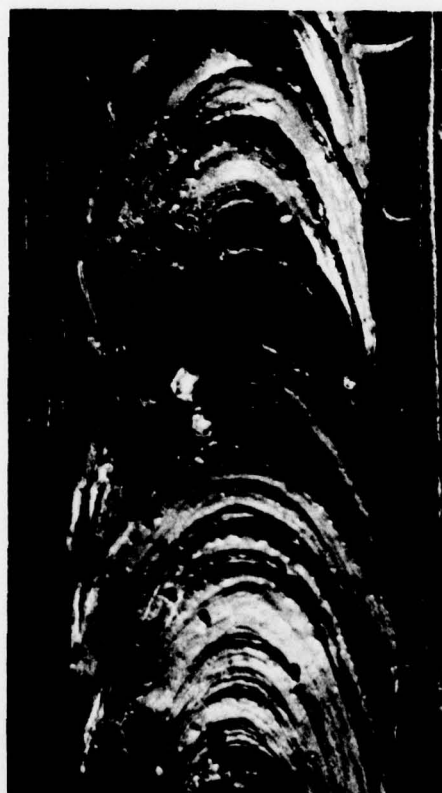
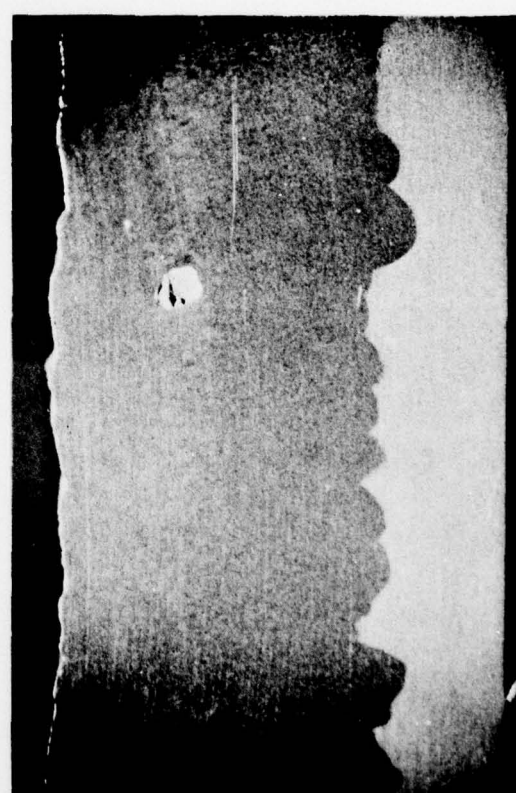
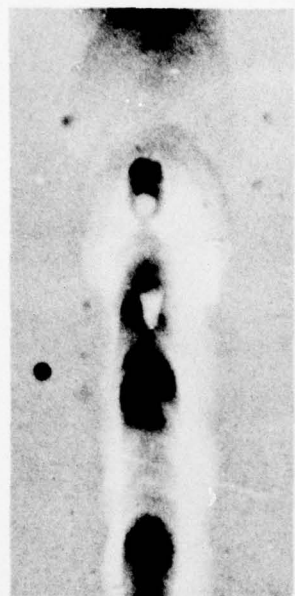
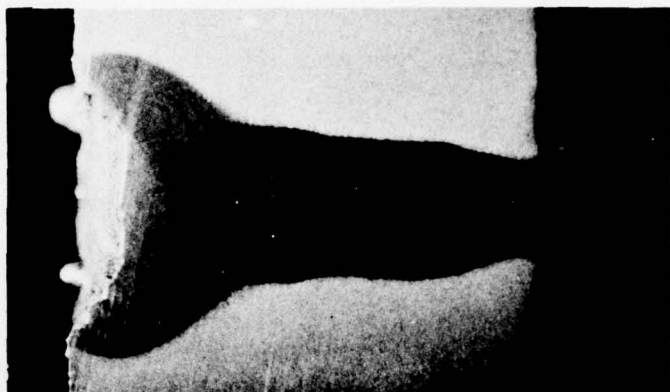
STRUCTURE OF WELD 35-5, 5086, TABLE III  
TOP SHIELD HELIUM FLOW RATE: 4.25 M<sup>3</sup>/HR' CROSS-JET OFF. 9 KW; 1.48 CM/S

A. WELD BEAD SURFACE

C. WELD MICROSTRUCTURE, LONGITUDINAL SECTION

B. RADIOGRAPH OF WELD SECTION/  
POROSITY APPEARS IN LIGHT CONTRAST

D. WELD MICROSTRUCTURE,  
TRANSVERSE SECTION

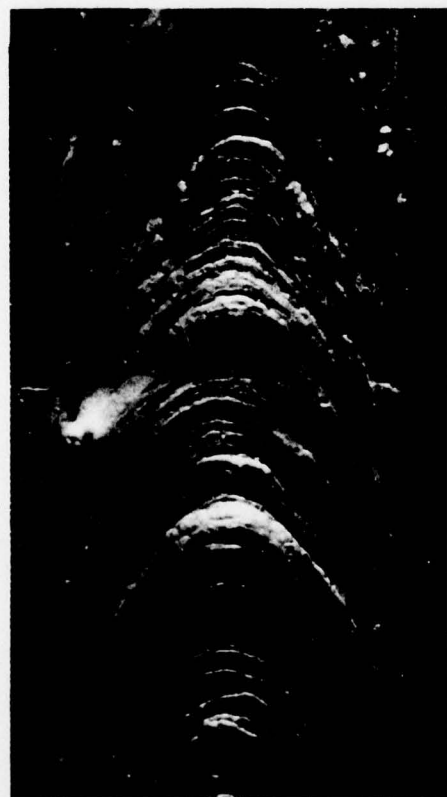
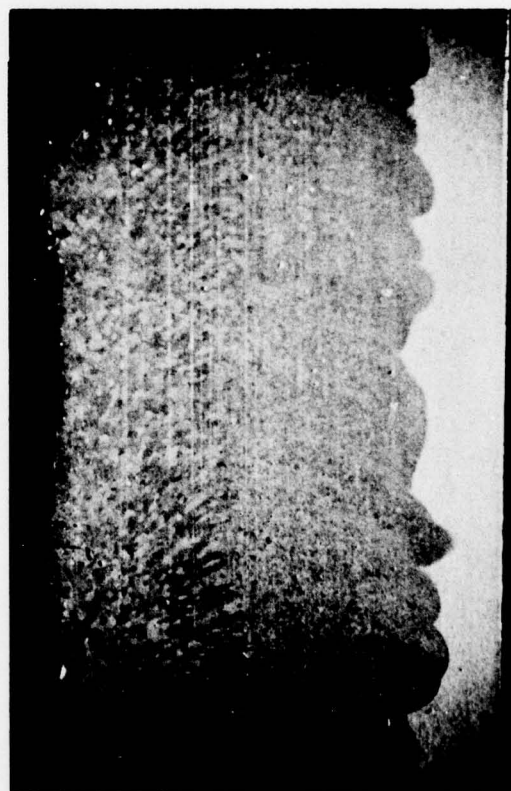
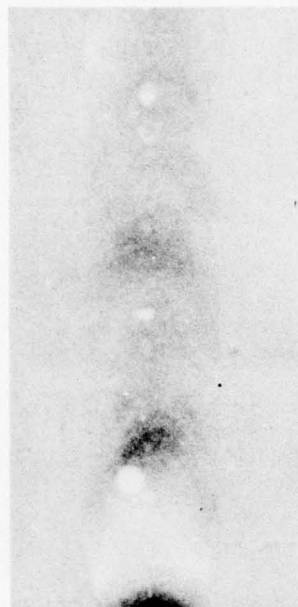
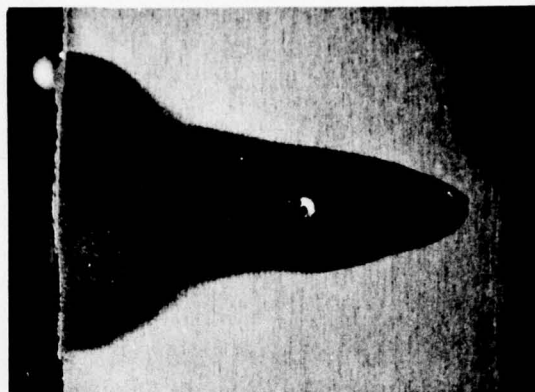
STRUCTURE OF WELD 35-6, 5456, TABLE III  
TOP SHIELD HELIUM FLOW RATE: 2.83 M<sup>3</sup>/HR. CROSS-JET OFF. 8.2 kW; 1.19 CM/S

A. WELD BEAD SURFACE

C. WELD MICROSTRUCTURE, LONGITUDINAL SECTION

B. RADIOGRAPH OF WELD SECTION  
POROSITY APPEARS IN LIGHT CONTRAST

D. WELD MICROSTRUCTURE,  
TRANSVERSE SECTION

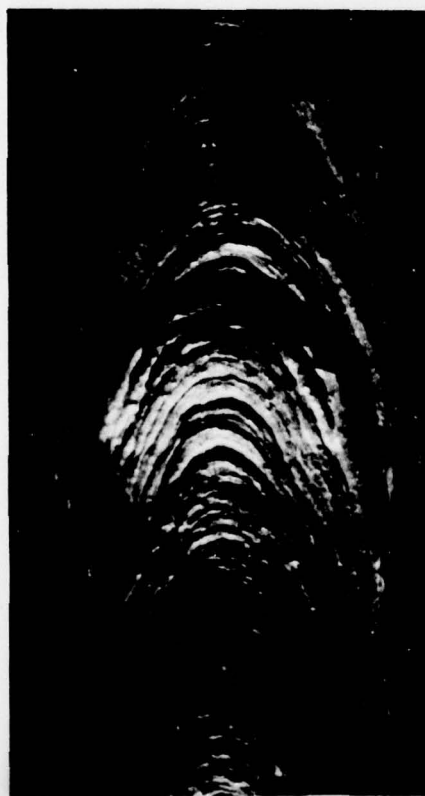
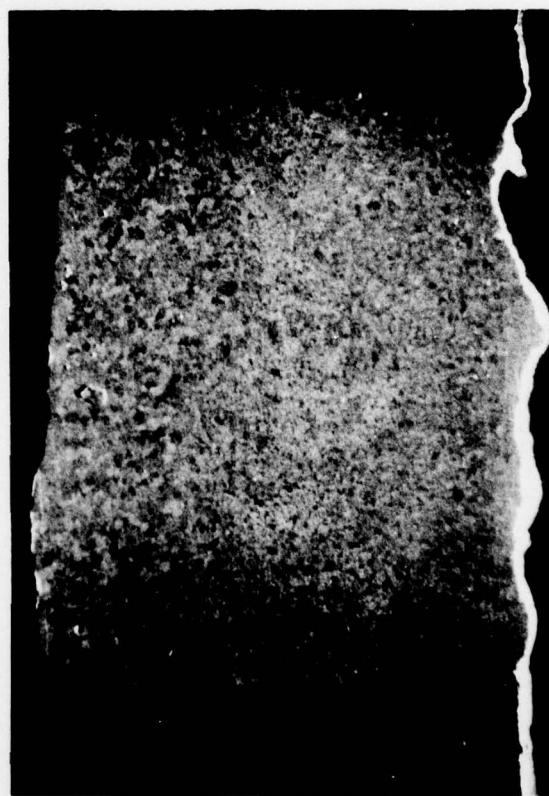
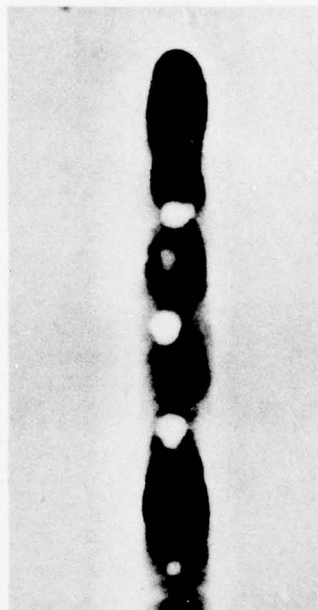
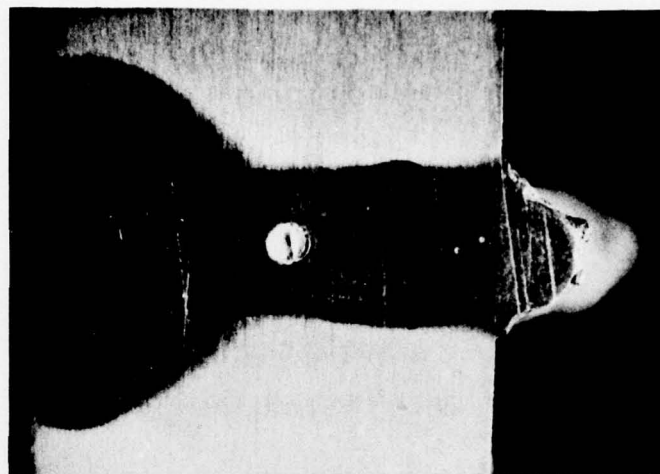
STRUCTURE OF WELD 35-7, 5456, TABLE III  
TOP SHIELD HELIUM FLOW RATE: 2.83 M<sup>3</sup>/HR. CROSS-JET OFF. 8kW; 1.19 CM/S

A. WELD BEAD SURFACE

C. WELD MICROSTRUCTURE, LONGITUDINAL SECTION

B. RADIOGRAPH OF WELD SECTION  
POROSITY APPEARS IN LIGHT CONTRAST

D. WELD MICROSTRUCTURE,  
TRANSVERSE SECTION

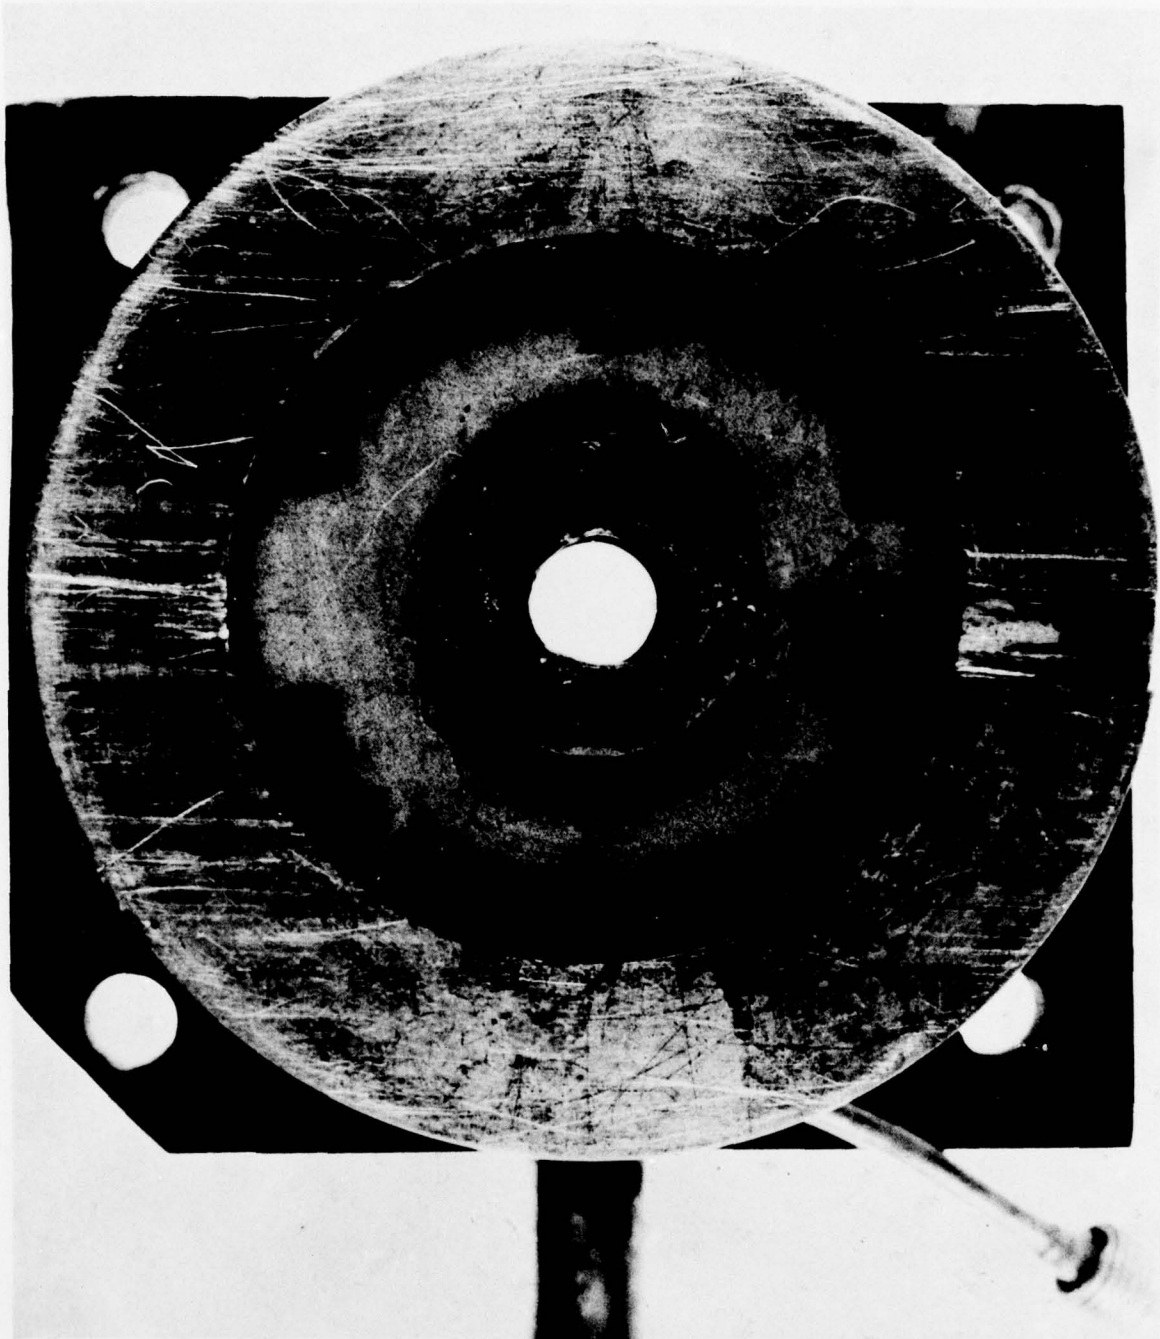
**CIRCULAR SHIELD USED FOR PHASES IV AND V  
OF ALUMINUM WELDING PROGRAM  
(BOTTOM VIEW)**

OUTER DIAMETER 8.9CM  
GAS DIFFUSER PLATE SURROUNDING THROAT IS ATTACHED WITH SCREWS  
GROOVE IN OUTER RING ACCOMMODATES WELD BEAD

Following a period of laser down time for maintenance and internal alignment, a new series of bead-on-plate welds was conducted using a new circular shield enclosure designed by UTRC laser engineer, C. O. Brown. This shield enclosure was intended to maximize the shield gas flow rate surrounding the beam entry path (shield throat), as well as the area around the point of beam impingement (Fig. 8). The shield height was set to give a 1.8 mm clearance above the workpiece. The focal plane of the beam focusing mirror (focal length, 45.7 cm) was set 3.2 mm below the upper surface of the specimens. A new surface cleaning procedure was also introduced in an attempt to generate a cleaner and more reproducibly smooth and uniform surface. A shallow, flat-bottomed channel of 0.13-0.18 mm depth was milled in the top and bottom surfaces of each specimen along the intended weld path with a portable router equipped with a tungsten carbide bit. Welding was subsequently conducted not more than one minute after router cleaning.

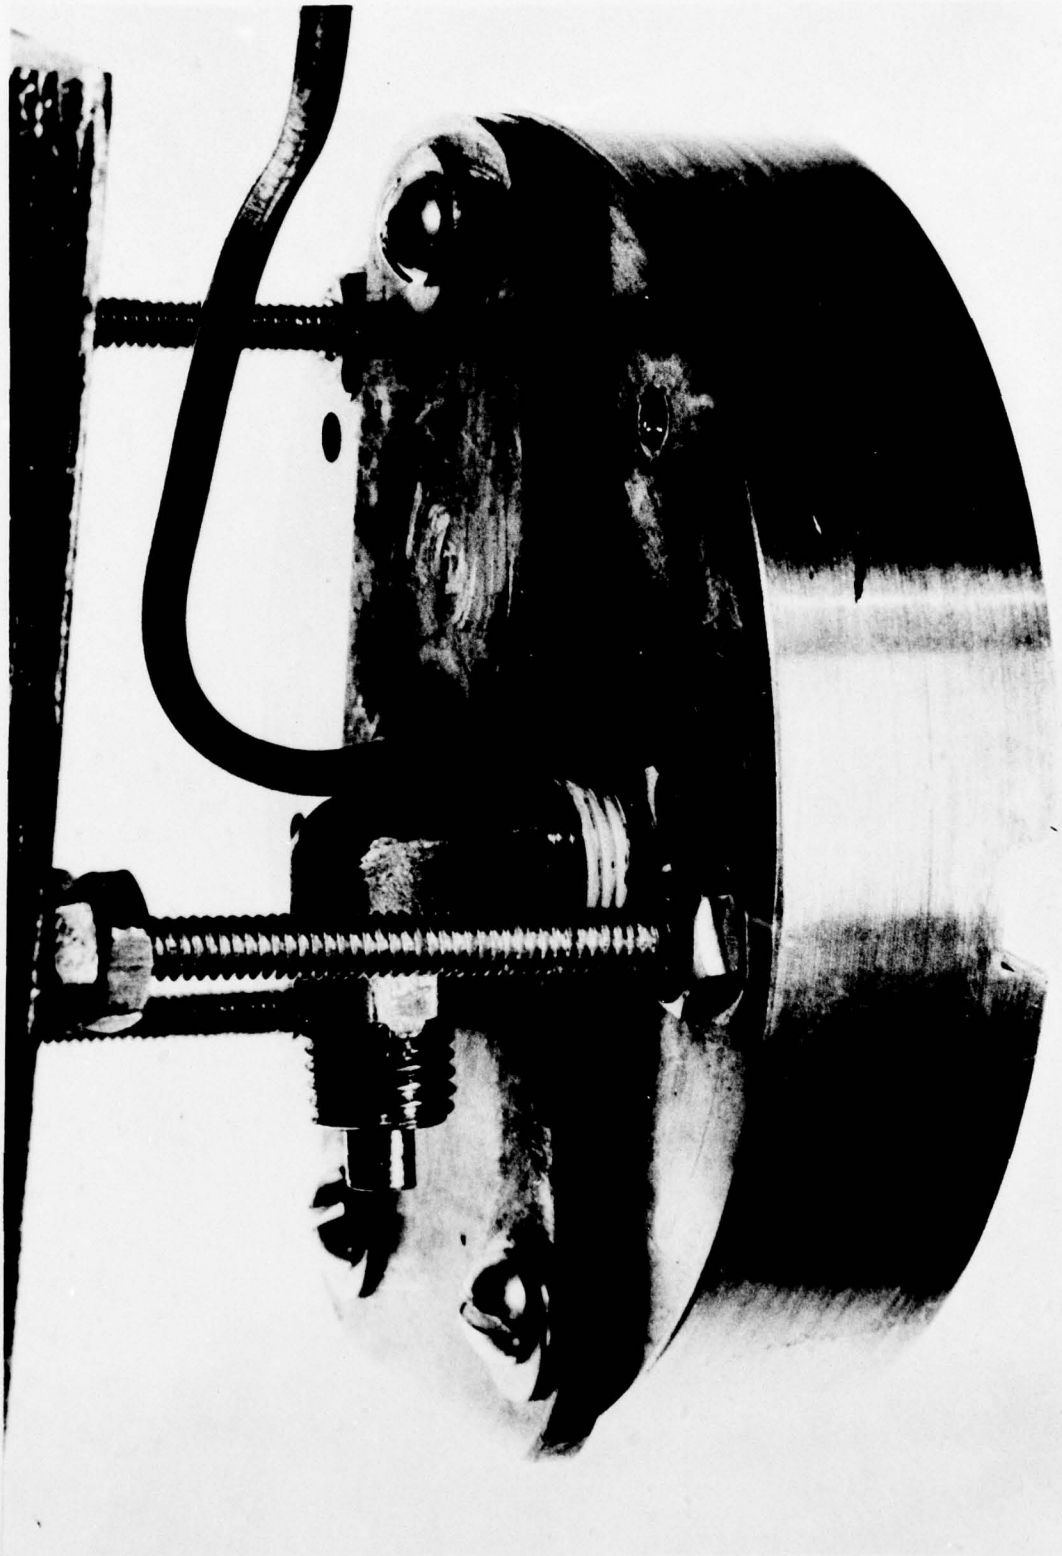
CIRCULAR SHIELD USED FOR PHASES IV AND V OF ALUMINUM WELDING PROGRAM  
(SIDE VIEW FROM REAR)

LONG SCREWS ATTACH SHIELD TO MOUNTING BRACKET  
FRONT (LARGER) INLET PORT FEEDS SHIELD GAS TO DIFFUSER PLATE  
SOLDERED (SMALLER) INLET TUBE FEEDS SHIELD GAS TO THROAT AREA

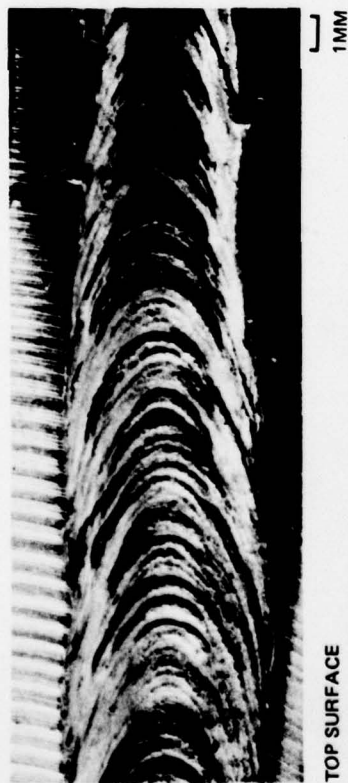
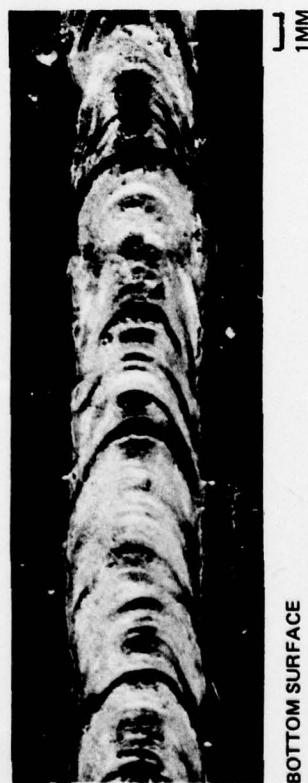
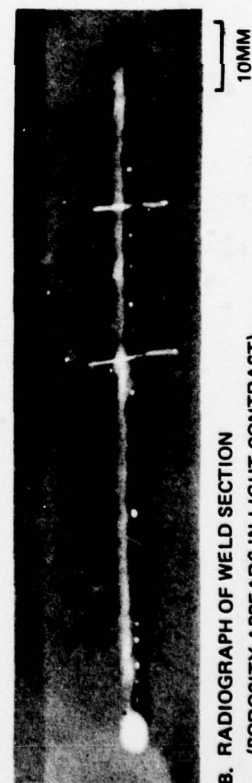
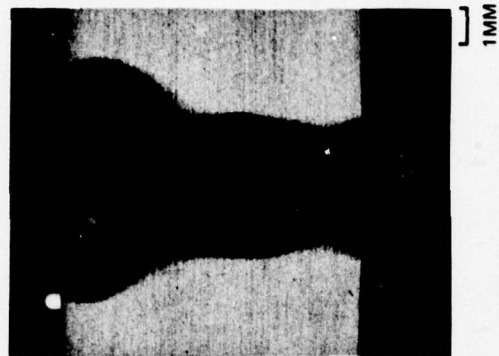
STRUCTURE OF WELD 64-41, TABLE IV  
BEAD-ON-PLATE WELD OF 0.64-CM, 5456, 5.5 kW, 1.69 CM/S

A. WELD BEAD SURFACES

B. RADIOGRAPH OF WELD SECTION  
(POROSITY APPEARS IN LIGHT CONTRAST)

C. WELD MICROSTRUCTURE,  
TRANSVERSE SECTION

As indicated by the data recorded in Table IV, small changes in shield gas flow rate resulted in substantial variation in fusion zone depth. In 0.64 cm 5456, an increase in the helium flow rate to the throat area from 1.42 to 2.12 m<sup>3</sup>/hr had approximately the same effect on depth of penetration as an increase in beam power setting from 5.5 to 7.5 kW. It also became evident that it was important to maintain a steady helium flow pattern across the specimen surface during welding. This condition was greatly facilitated by the use of end and side plates of 0.64 cm aluminum stock butted against the sides of the specimen to be welded. This maintained a constant gap between the bottom edge of the shield enclosure during the welding. As with the throat area flow rate, a rapid and steady flow of helium was essential for consistent depth of fusion zone penetration, presumably by removing plasma from the beam path.

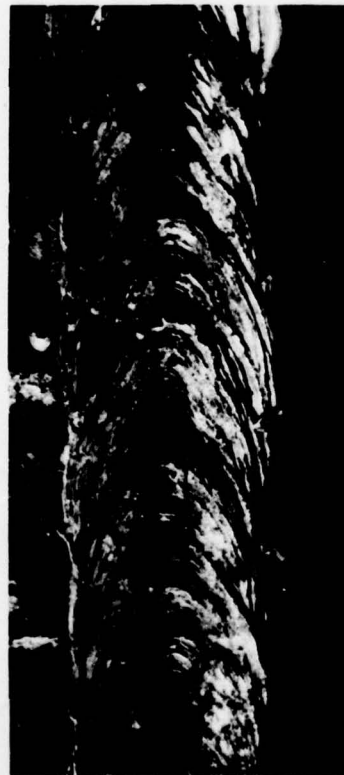
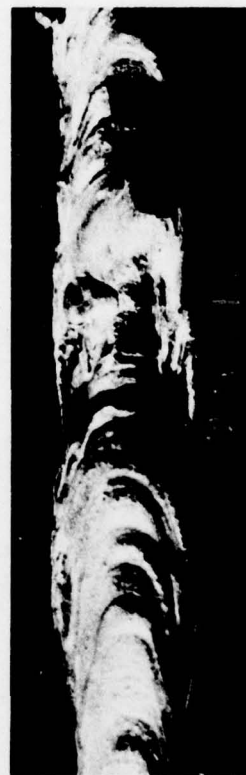
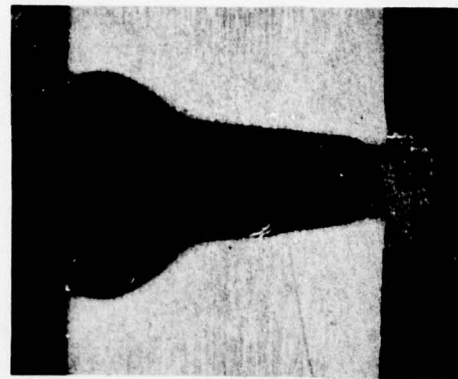
STRUCTURE OF WELD 64-47, TABLE IV  
BEAD-ON-PLATE WELD OF 0.64-CM, 5086, 6.3 kW, 1.69 CM/S

TOP SURFACE

BOTTOM SURFACE

A. WELD BEAD SURFACES

B. RADIOGRAPH OF WELD SECTION  
(POROSITY APPEARS IN LIGHT CONTRAST)

C. WELD MICROSTRUCTURE,  
TRANSVERSE SECTION

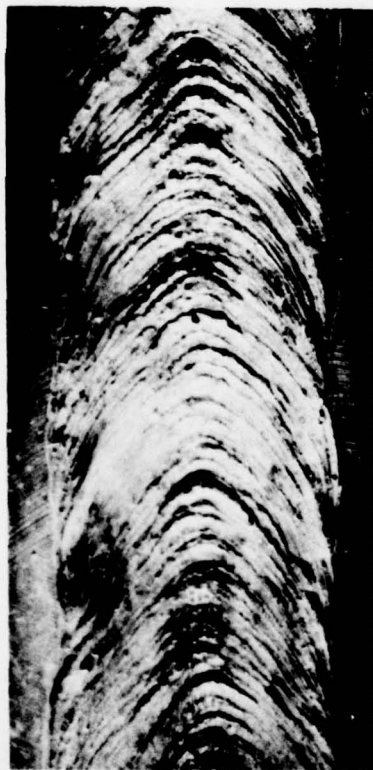
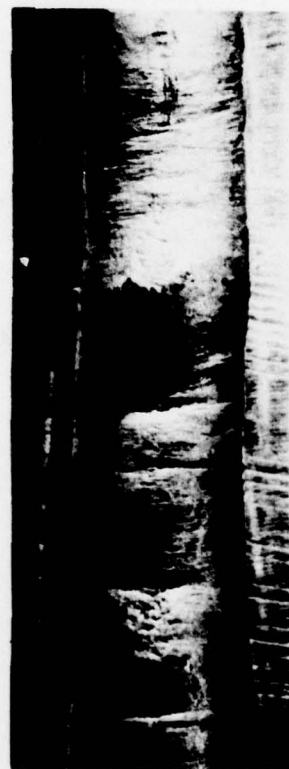
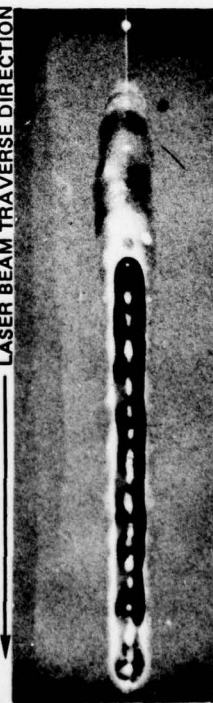
STRUCTURE OF WELD 66-72, TABLE V  
BUTT WELD OF 0.95-CM, 5456, 7.9 kW, 1.69 CM/S

BOTTOM SURFACE  
A. WELD BEAD SURFACES

C. WELD MICROSTRUCTURE,  
TRANSVERSE SECTION

B. RADIOGRAPH OF WELD SECTION  
(POROSITY APPEARS IN LIGHT CONTRAST)

unique to 0.64 cm plate. The bead-on-plate welds essentially duplicated the results obtained previously (Table V, Figs. 11-13). Alloy 5086 required higher energy to weld than 5456, and complete fusion zone penetration was accompanied by drop-through and an underfilled bead on the top surface.

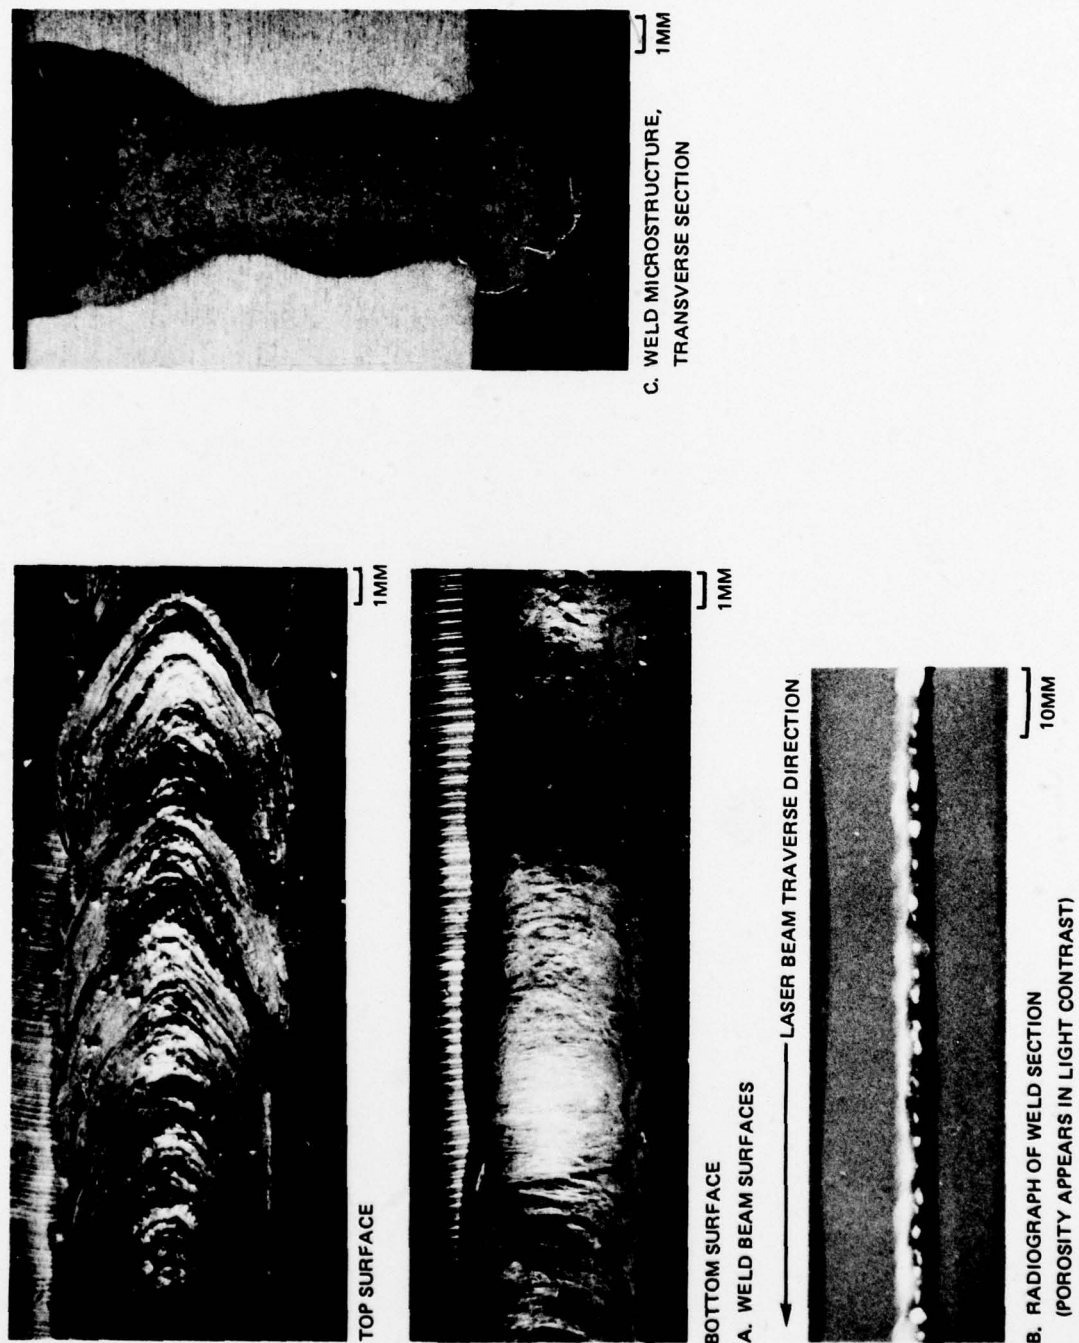
STRUCTURE OF WELD 68-83, TABLE V  
BUTT WELD OF 0.95-CM, 5456, 7.0 kW, 1.69 CM/S

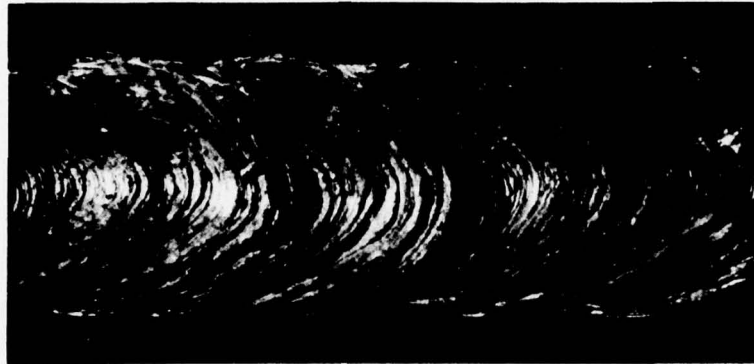
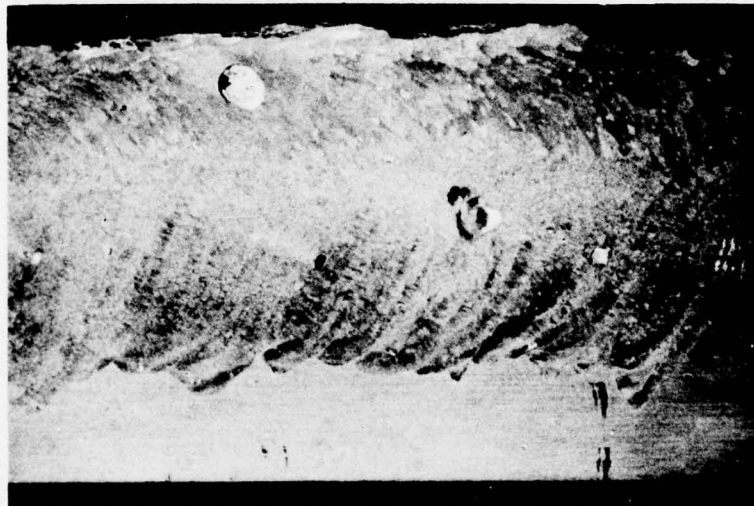
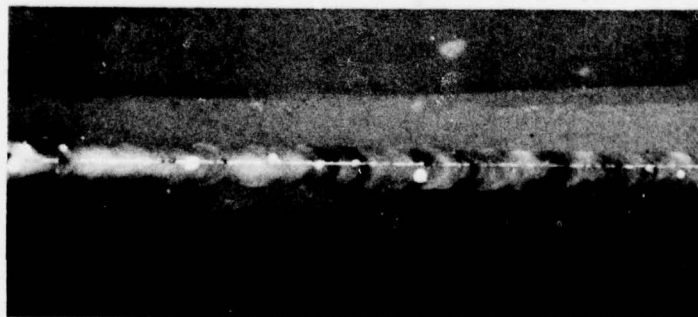
STRUCTURE OF WELD 68-85, TABLE V  
BUTT WELD OF 0.95-CM, 5086, 7.5 kW, 1.69 CM/S

A. WELD BEAD SURFACE

B. WELD MICROSTRUCTURE,  
LONGITUDINAL SECTION

C. RADIOGRAPH OF WELD SECTION  
(POROSITY APPEARS IN LIGHT CONTRAST)

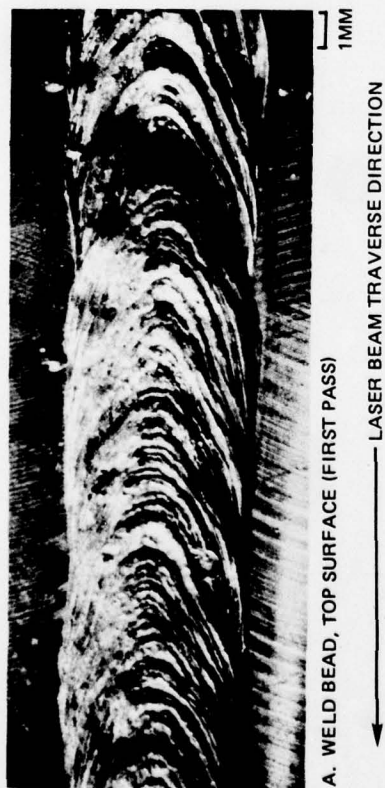
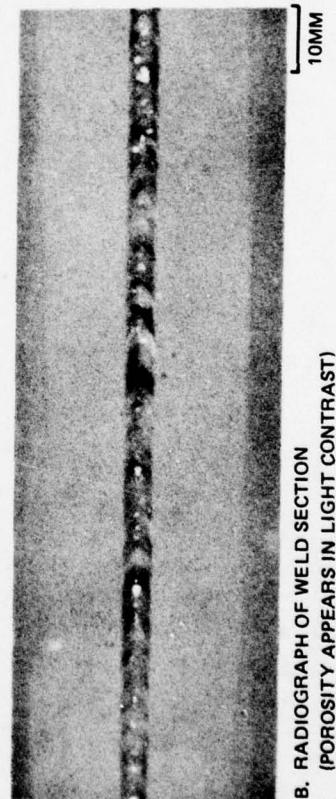
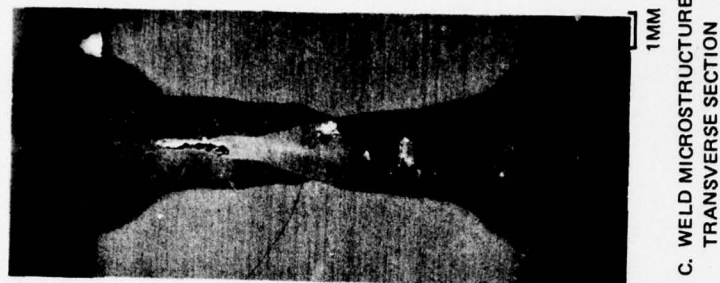
STRUCTURE OF WELD 70-87, TABLE VI  
TWO-SIDED BUTT WELD OF 0.95-CM, 5456, 7.0 kW, 3.39 CM/S

Drop-through during butt welding was eliminated by the use of two-sided welding (Figs. 14-15). However, fusion zone porosity continued to occur, together with the intermittent appearance of porosity at the root of the second weld (Fig. 14).

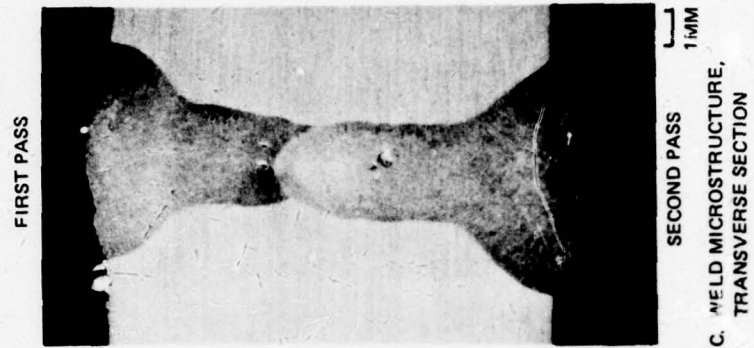
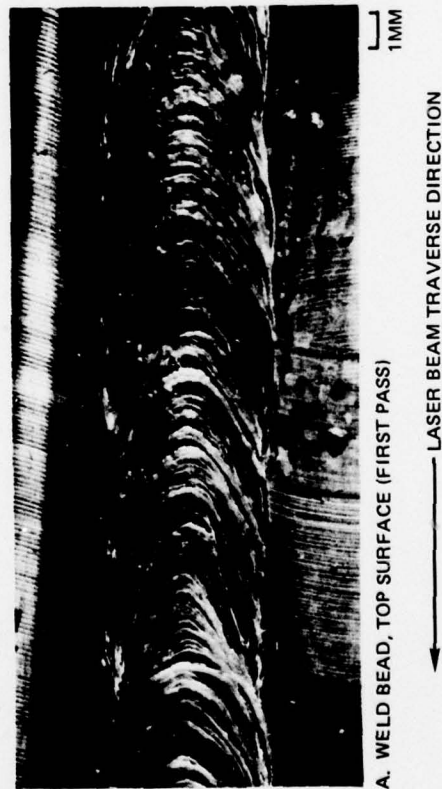
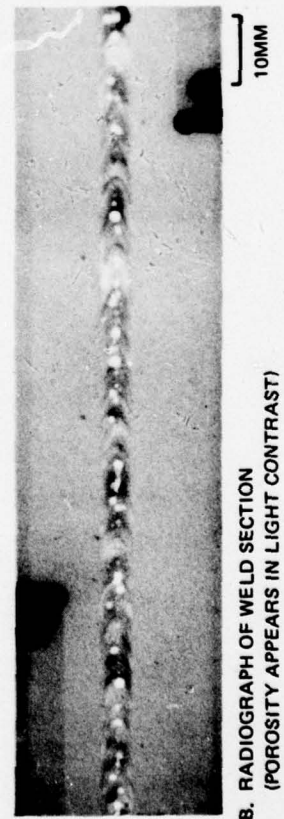
STRUCTURE OF WELD 70-88, TABLE VI  
TWO-SIDED BUTT WELD OF 0.95-CM, 5086, 7.0 kW, 3.39 CM/S
